Manhole Inspection Summary

Manhole # S25Q1_012MH

Insp Date: **3/5/08 1:11 PM**

Location Address: **3115 Magnolia Ave**

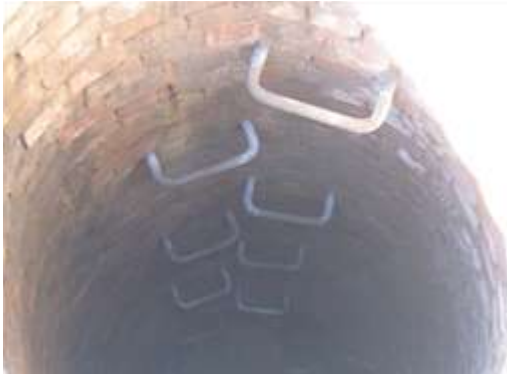
Steps Count: **8** Missing: **0** ☐ Corroded

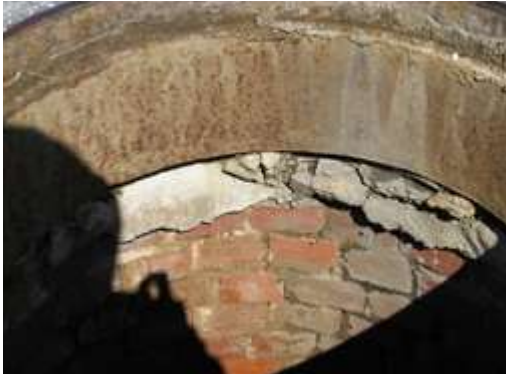
Defect 1

Infiltration: ☐ None ☐ Joint ☐ Cracks ☒ Mortar ☐ Roots ☒ Wall

Chimney

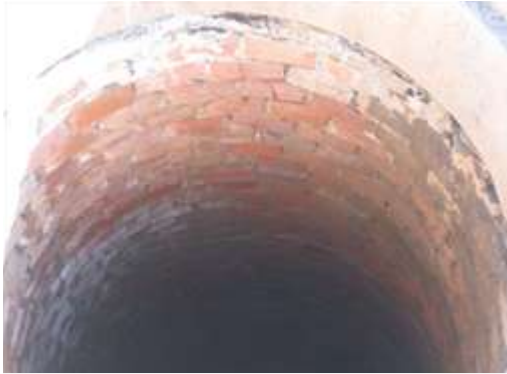
Defect 2

Wall

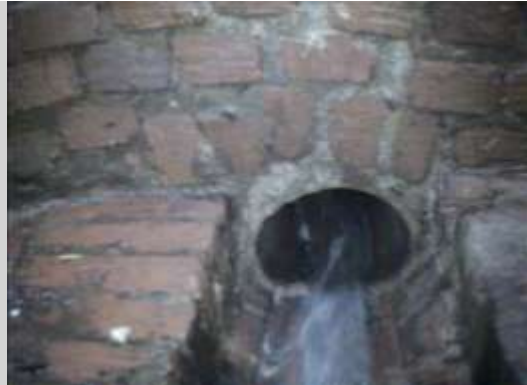
12 O'Clock Outflow

8 in. Circular Gravity Sewer
Pipe Out @ 12 O'Clock

Pipe Height: **10.8** (in.) Rod and Bar (Angled)
Pipe Material: **Clay** ☐ Pipe Lined
Invert Depth: **15.11** (ft.) Flow Characteristics: **Fast**
Deposits: ☒ None ☐ Mud ☐ Sludge ☐ Debris ☐ Grease
Silt Depth: (in.) Deposits Extent:
Infiltration: **None** Pipe Seal Cond: **Sound**

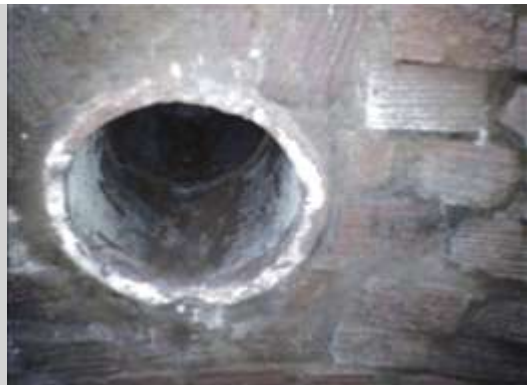
6 O'Clock Inflow

8 in. Circular Gravity Sewer
Pipe In @ 6 O'Clock

Pipe Height: **8.4** (in.) Rod and Bar (Angled)
Pipe Material: **PVC** ☐ Pipe Lined
Invert Depth: **8.92** (ft.) Flow Characteristics: **Fast**
Deposits: ☒ None ☐ Mud ☐ Sludge ☐ Debris ☐ Grease
Silt Depth: (in.) Deposits Extent:
Infiltration: **None** Pipe Seal Cond: **Sound**

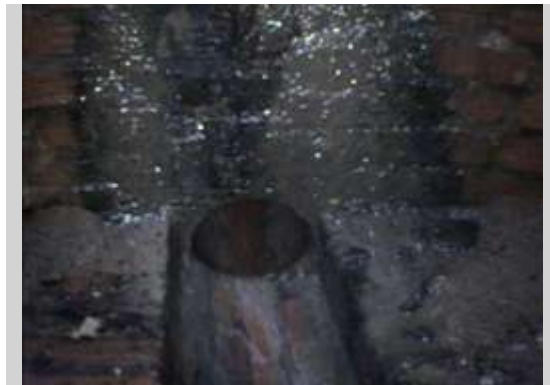
Drop In @ 6 O'Clock

Drop: **Outside** Rod and Bar
Angled: **Yes** Reading: **13.79** (ft.)
Inv Depth: **14.79** (ft.)
Drop Condition: **Open**
